Manhole Inspection Summary

Manhole # S65G__021MH

Location Address: **336 Folcroft St.**

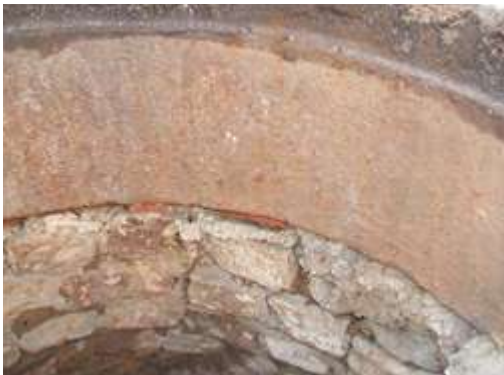
Defect 2

Condition: ☐ Sound ☐ Cracked ☐ Root Intrusion ☒ **Loose Brick** ☒ **Deteriorated**

loose bricks

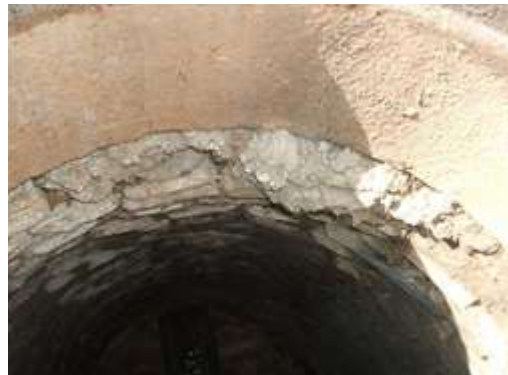
Defect 1

deterioration

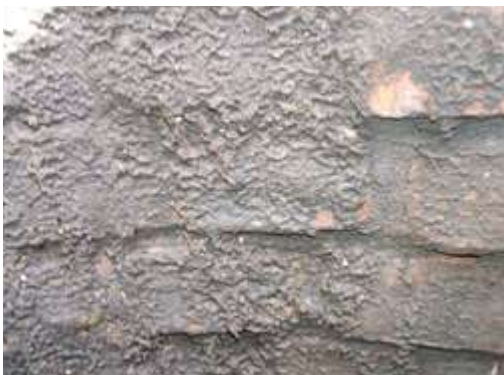
Defect 6

infiltration

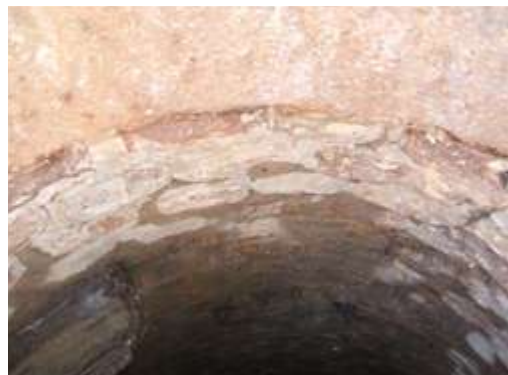
Defect 8

Infiltration: ☐ None ☒ **Joint** ☐ Cracks ☒ **Mortar** ☐ Roots ☒ **Wall**

infiltration in barrel

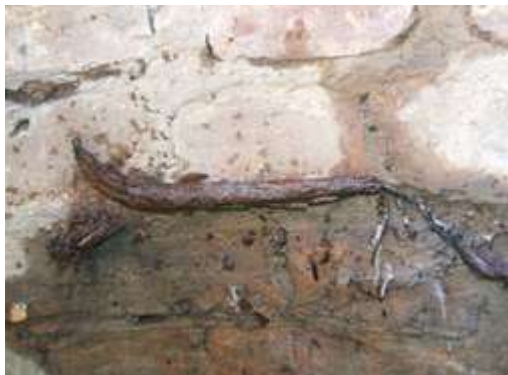
Defect 7

infiltration

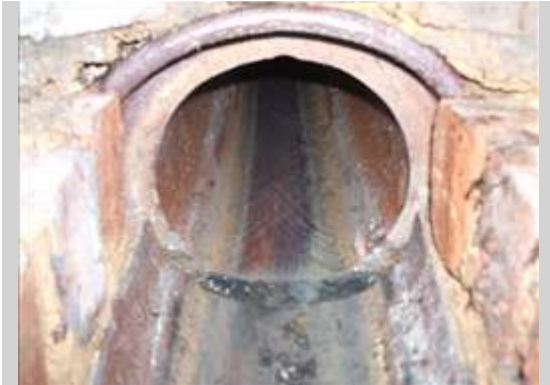
12 O'Clock Outflow

8 in. Circular Gravity Sewer
Pipe Out @ 12 O'Clock

Infiltration: **None** Pipe Seal Cond: **Sound**

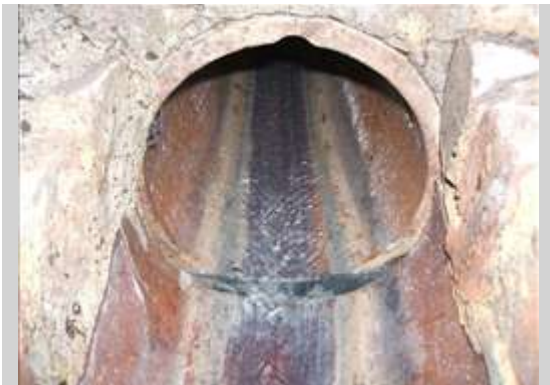
6 O'Clock Inflow

8 in. Circular Gravity Sewer
Pipe In @ 6 O'Clock

Infiltration: **None** Pipe Seal Cond: **Sound**
